# No. 325 1968 Volvo 144S

## Condition Summary Bodywork

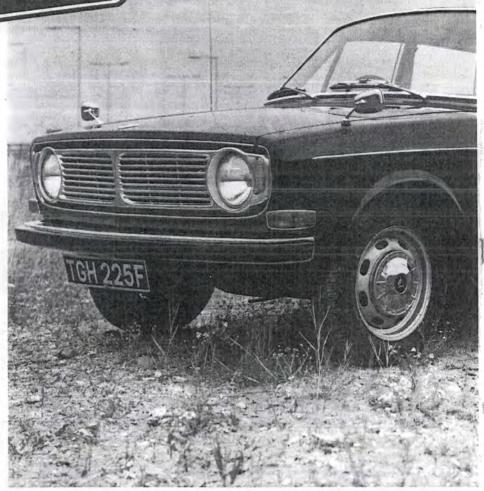
Left: The original dark blue paintwork has lasted well. Bright metal, which is mainly stainless steel or aluminium, is good, with the exception of the rear bumper

The original midnight blue paint finish is generally good, but some chips and small dents have been rather badly touched in with a brush. Bright metal, which is stainless steel or aluminium almost everywhere, is in very good condition and there are no signs of accident damage. The aluminized plastic trim over the rear number plate has started to separate and the rear bumper is beginning to pit.

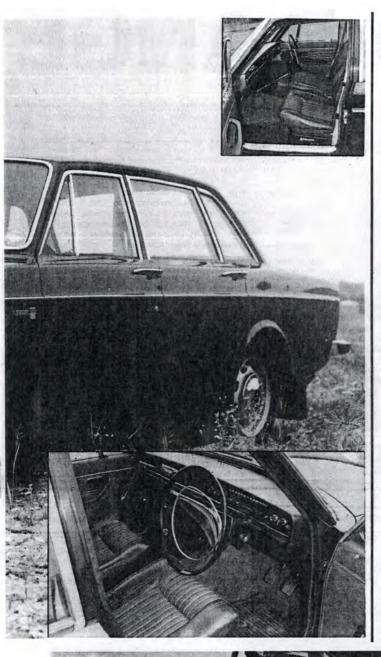
Inset left: The whole car has been well prepared for sale and looks immaculate

Left: There is nothing to indicate inside that this is not a brand new car

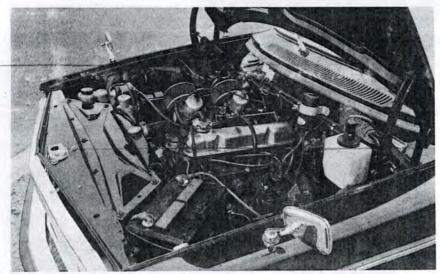
Below: The engine has been cleaned down and shows no signs of any fresh oil leaks

Performance is not quite up to the standards of the car when new, but still brisk overall, with O to 60 mph possible in under 14 sec without recourse to our normal violent getaway techniques. The clutch had more than enough bite to cope and the engine had no abnormal taps or rattles. The engine had been well cleaned and there were no traces of oil leaks anywhere. There is no more than the usual amount of free play in the steering and the dampers are still very effective.
